PREPARED BY:
CHEMICAL AND SCIENTIFIC SECTION
INDUSTRIAL BRANCH, IAD

## LU-CHOU NITROGEN FERTILIZER PLANT LU-CHOU, CHINA

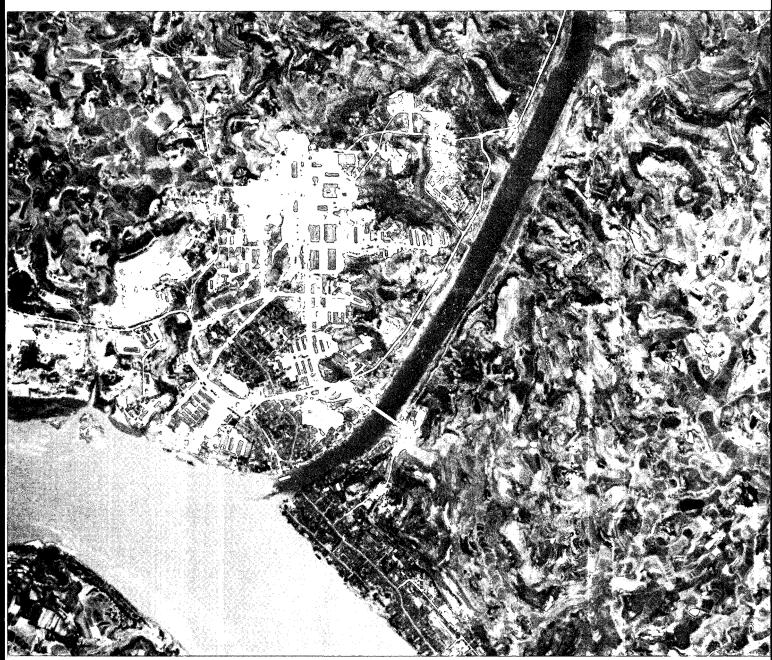
LU-CHOU NITROGEN FERTILIZER PLANT LU-CHOU, CHINA 28 46N - 105 22E

(4) Figure 5 - The prilling tower, the four fabrication buildings, and the water treatment facility (Annotations 9, 12, and 14) appeared complete on this mission. The larger power plant (Annotation 5) also appeared complete and in operation as indicated by smoke coming from its stacks. In addition, the spray pond was in operation indicating that either one or both power plants were in use. Construction of a cooling tower and water intake (Annotations 1 and 16) had taken place. Under construction were two probable spheroidal tanks, the ammonia synthesis building, a probable prilled urea storage building, and a conveyor (Annotations 3, 4, 10, and 13). The footings for a conveyor or pipeline were under construction (Annotation 7) as well as pipelines serving the various facilities. A tall structure was apparent

on the southwest side of the processing building (Annotation 15).
